QUARTZELEC WHITE PAPER

Damaged generator rotors: the economic and logistical benefits of repair over scrappage. New advances in repair techniques and stress analysis extend the feasibility of a repair further than traditionally thought.

The following scenario occurred on a 155 MVA generator in a Ghanaian power station, causing severe damage to several rotor components. The customer report confirmed that undefined issues with one of the circuit breakers may have occurred, tripping the generator during run-up. Subsequent attempts to start the machine were unsuccessful and the decision was made to remove the rotor and conduct the appropriate investigation.

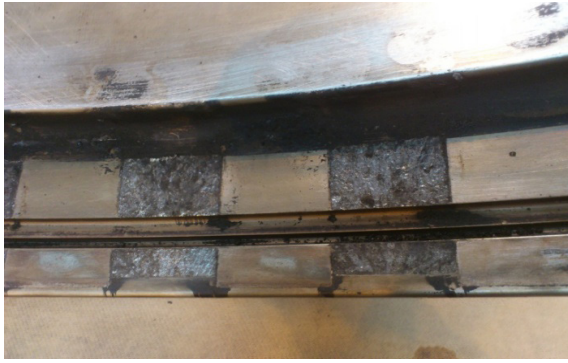
Figure 2 & Figure 3 (overleaf) clearly show severe damage caused by high currents flowing in the damper circuit during the motoring incident. When the rotor is stationary, there are no centrifugal forces to load the slot content against the rotor to cause full contact between the ends of the rotor slot wedges and the end winding retaining rings. Full contact between the slot wedge flanks and wedge slot flanks also becomes intermittent.

The majority of induced currents flow through the aluminum wedges and rotor body surface, causing substantial heat to be produced when a high resistance joint occurs between two damper circuit components. This explains the severe arcing damage on wedge tips, flanks and retaining rings. Similar damage was found in every slot dovetail.

Figure 2. Molten retaining ring fit area

- Both retaining rings showed evidence of severe arcing damage and were scrapped.
- Existing retaining rings were reverse engineered. New retaining rings were manufactured from 18/18 material to ASTM A289.

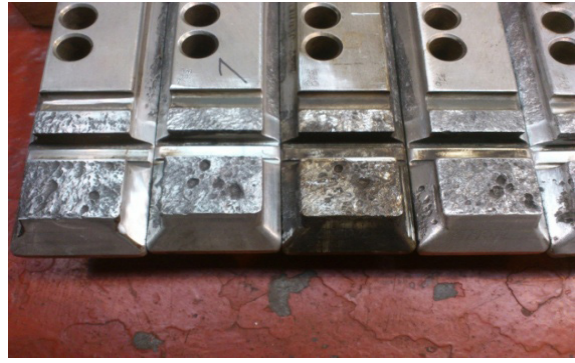
Figure 3. Molten wedges

- All aluminium wedges showed evidence of severe arcing damage along their entire length and were deemed unfit for use.
- Because the rotor slot dovetails were opened to remove arcing damage, new wedges were required.
- Existing aluminium wedges were reverse engineered.
- New wedges were manufactured to incorporate new modified shape and original vent hole configuration.

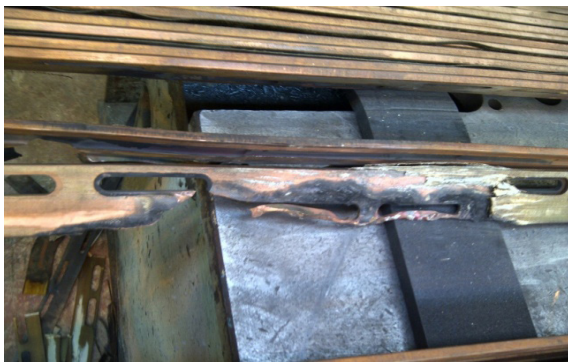
In addition, almost 20% of the copper winding on the rotor had either been melted away or suffered severe distortion. See Figure 4 & Figure 5 below.

Figure 4. Molten copper from slot 24

- The rotor copper was thoroughly inspected to identify damaged turns.
- Hardness tests were conducted to review the condition of coils affected by high temperatures.
- Collapsed copper corners were found on every top turn, prompting the decision to replace every coil.
- Approximately 20% of the winding was deemed unsuitable for re-use.
- New copper turns were manufactured using silver bearing copper, drawn to incorporate the contraflow cooling system.

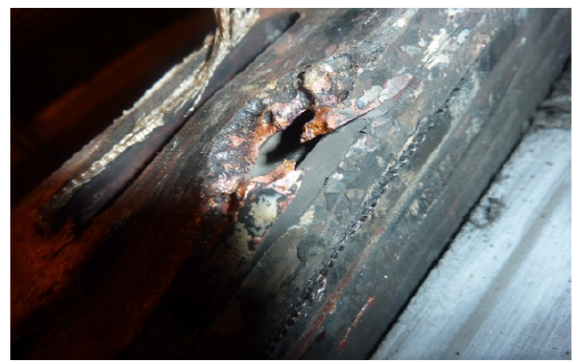
Figure 5. Molten copper from slot 11

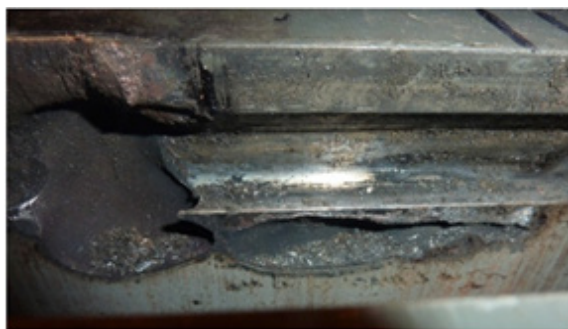
Later investigation confirmed the presence of a double earth fault, resulting in severe arcing damage. Two deep excavations (250mm and 300mm axially, up to 20mm deep) were found within two of the forging slots where material had vaporized at the site of the earth faults. It is believed that an earth fault had occurred during attempts to run the generator after the motoring incident. See Figure 6 & Figure 7 below.

Figure 6. Molten tooth in slot 11

- The locations of the earth fault on the rotor body were dressed out.
- Metallographic replicas to make sure that the heat affected zone was completely removed.
- Additional hardness tests were conducted in multiple locations around the damaged area.
- A weld repair to the rotor body was subsequently carried out (See Figure 8 overleaf).

Once the excavations had been prepared by the removal of heat-affected areas – confirmed by performing a set of material replicas and additional hardness tests – preparation for TIG welding commenced. The rotor forging was preheated to increase the strength of the weld and provide finer weld structure by full martensite transformation using highly accurate temperatures. The welding was then carried

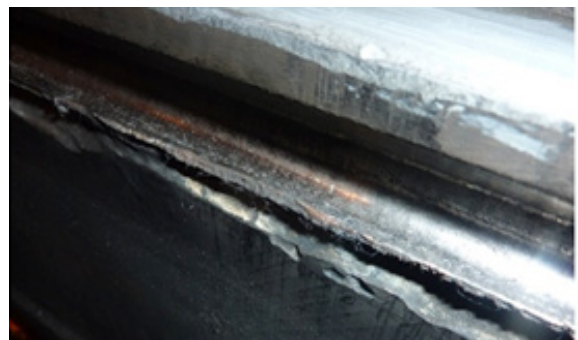
Figure 7. Molten tooth in slot 24

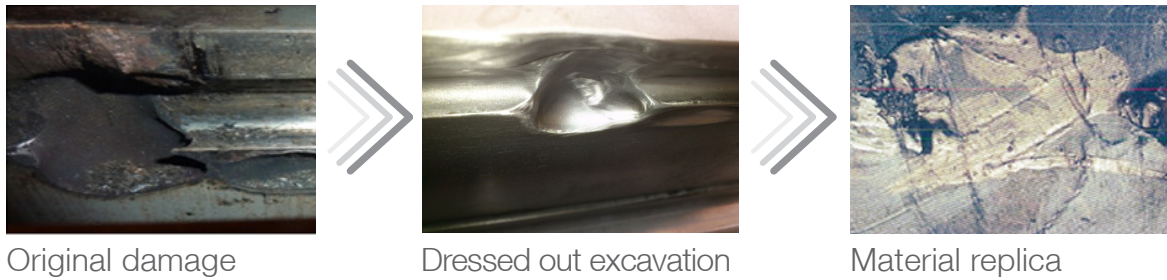
Figure 8. Earth fault location recovery process

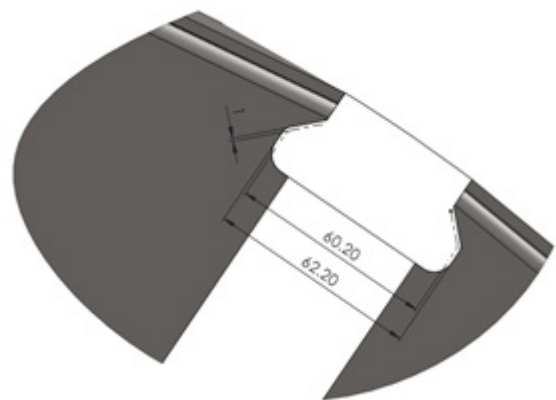
Figure 10. New profile dimensions and the old in chain dotted

The Von Mises stress between the two profiles changes by only 8.7% for the increase in width.

- Severe arcing damage was confirmed in all rotor dovetails.
- The depth of the most severe damage was measured.
- It was identified that it was necessary to open every slot by 1mm in order to remove all damage.
- Stress analysis of the rotor teeth was conducted to prove the mechanical integrity of the new dovetail and wedge design (see Figure 8 overleaf).

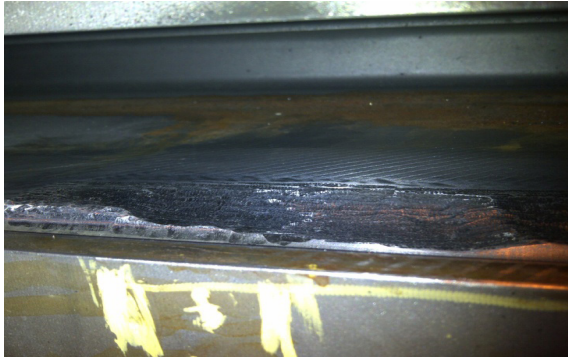
Figure 19. Slot 24 ready for weld repair

out in accordance with internal processes at previously agreed parameters by highly experienced welders specialising in this procedure. The welding locations were then carefully dressed to allow NDT inspection. Both magnetic particle and ultrasonic tests were carried out by a specialist NDT technician with over 35 years experience to confirm effective fusion between materials. Finally, both weld locations were hand-polished and the forging stress relieved in accordance with company internal specifications.

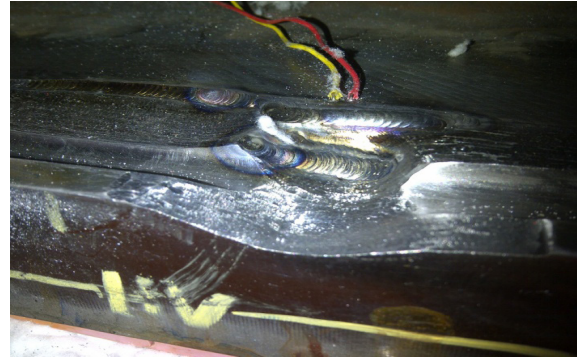
Figure 20. Slot 11 ready for weld repair
