QUARTZELEC WHITE PAPER

Damaged generator rotors: the economic and logistical benefits of repair over scrappage. New advances in repair techniques and stress analysis extend the feasibility of a repair further than traditionally thought.

The following scenario occurred on a 155 MVA generator in a Ghanaian power station, causing severe damage to several rotor components. The customer report confirmed that undefined issues with one of the circuit breakers may have occurred, tripping the generator during run-up. Subsequent attempts to start the machine were unsuccessful and the decision was made to remove the rotor and conduct the appropriate investigation.

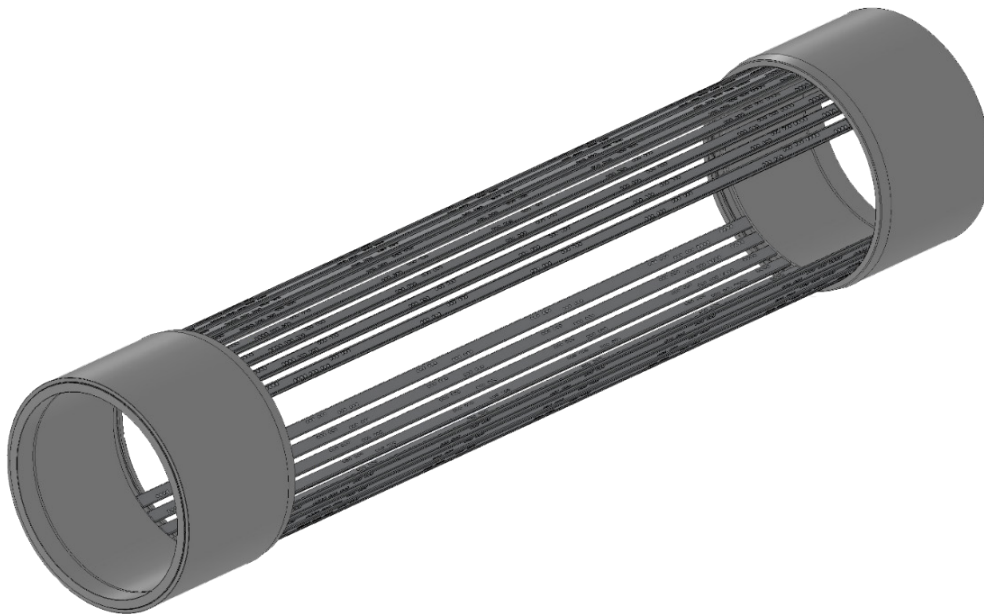
The situation changes dramatically if the generator rotor is running at low speed or standstill and the main circuit breaker has been inadvertently closed. Under such conditions, the generator attempts to run as a squirrel-cage motor, using a damper circuit (Figure 1). High currents flowing through the stator winding induce a 50Hz current flowing in the rotor components. Due to lack of centrifugal force, high resistance is created between squirrel-cage components, generating excessive heat. The rotor will try to accelerate, but the presence of rectification diodes within the excitation system will allow only half cycle current to flow through the damper circuit, successfully reducing the rotor speed. Bitter experience shows that generators exposed to this condition can be permanently damaged in a matter of seconds.

Figure 1. Rotor damper circuit made from wedges and retaining ring

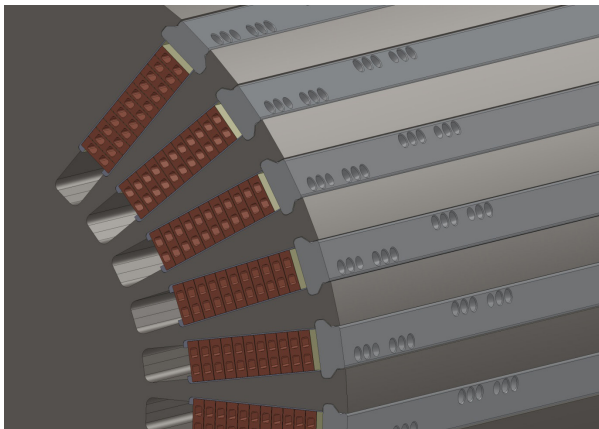
The rotor is machined from a low alloy steel Ni, Cr, M having 0.2% proof stress of 600-700MPa. The rotor has longitudinal slots to give the correct location for the copper stack to be positioned as Figure 9 below.

The forces generated by rotation are restrained against radial movement by the aluminium wedge that locates in the dovetail profile of each rotor slot, see Figure 9.

Figure 9. Rotor slot content

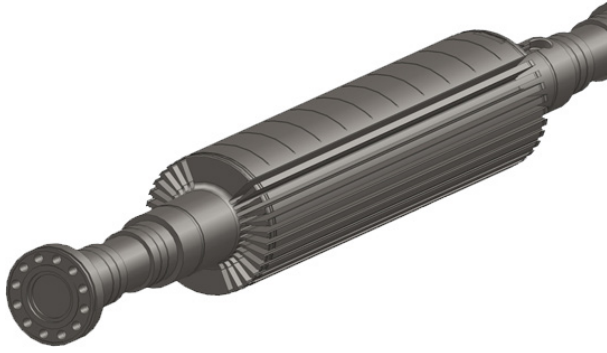
The rotor slots are distributed symmetrically about the rotor's Z axis – a feature used to reduce the FEA model down to two slots. The slot was also loaded uniformly along the length of the wedge due to the mass of the copper and the aluminium wedge acting on the dovetail profile. This enabled a 100mm section to be taken to represent the rotor length, see Figure 11 & Figure 12.

Figure 11. Rotor forging – general view

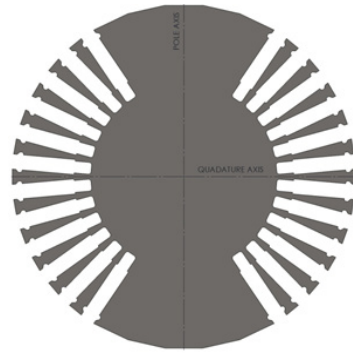
Figure 12. Rotor forging cross section through rotor body

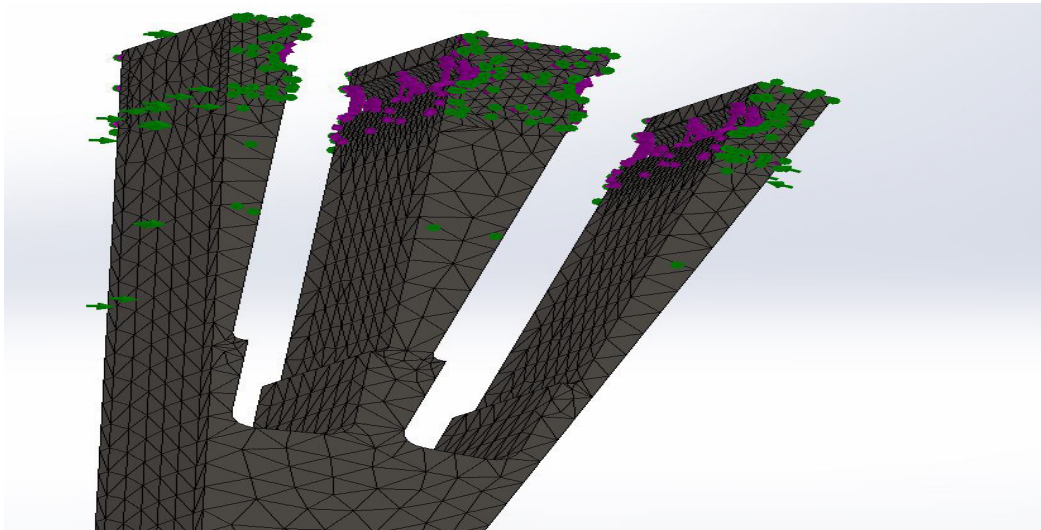
The model was restrained against movement in the Z axis (axis of rotation) on the faces – and normal to the radial faces – leaving the section free to move in the radial directions.

Figure 13. Restraints and applied load to profile flanks

Loads representing the copper and aluminium mass were applied to the dovetail flanks, orientated normally to a plane in the centre of the slot and reducing the FEA model to a single component. The applied centrifugal force was calculated using the restrained masses, their centre of gravity and the rotor speed, thus:

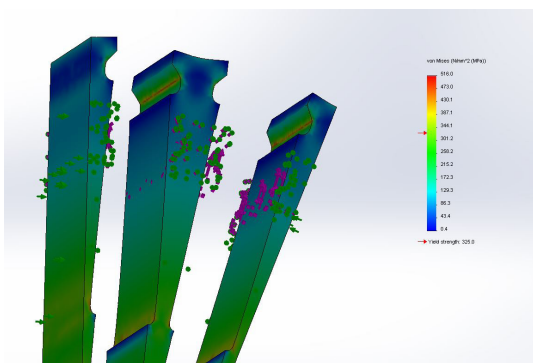
Figure 14. Stress pattern, original slot profile

Whilst not the deciding factor, the predicted stress for the groove was higher than expected, for both profiles. To check that the FEA model had not been over simplified, an additional simulation was conducted with the wedge included in the model and loaded against the slot flank profile.

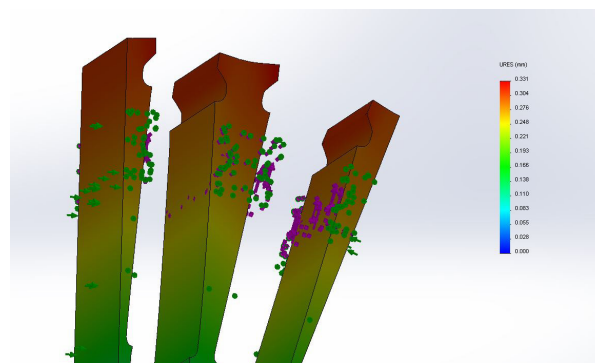
Figure 15. Displacement pattern, original slot profile

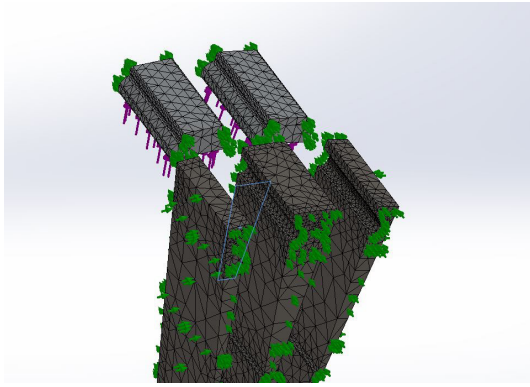
The meshing and restraints used the same symmetry principle as for the simple FEA model, with the contacting flanks of the wedge mated to the rotor slot profile for a no penetration contact. This contact allows for sliding motion between the two faces and more realistic simulation; NB the figures overleaf show the model in an exploded view.

Figure 16. Medium mesh with wedges in exploded view

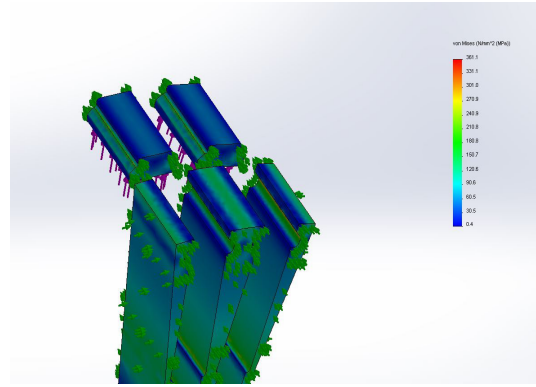
Figure 17. Stress pattern

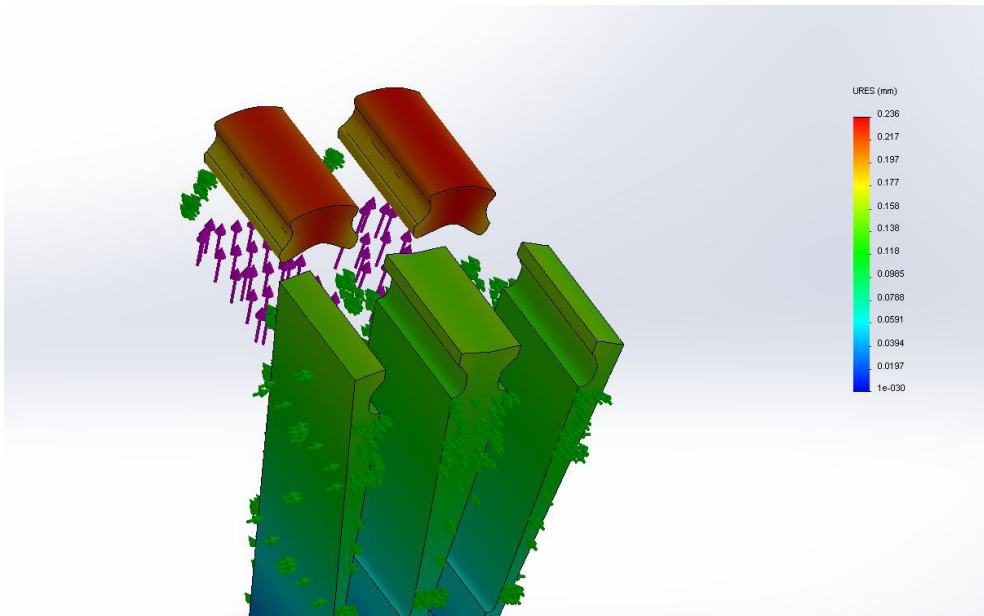
Figure 18. Displacement pattern

This also confirmed that the bending stress on the aluminium wedge remained within a reasonable level, despite the slight increase in span.
